GEOLOGICAL & GEOTECHNICAL SITE INVESTIGATION REPORT

ON
PROPOSED 3 STORY ELDERLY HOME

AT
PADUKKA ROAD, GODAGAMA.

Report No: 2482 (Report Date: 2025 Jan 31)

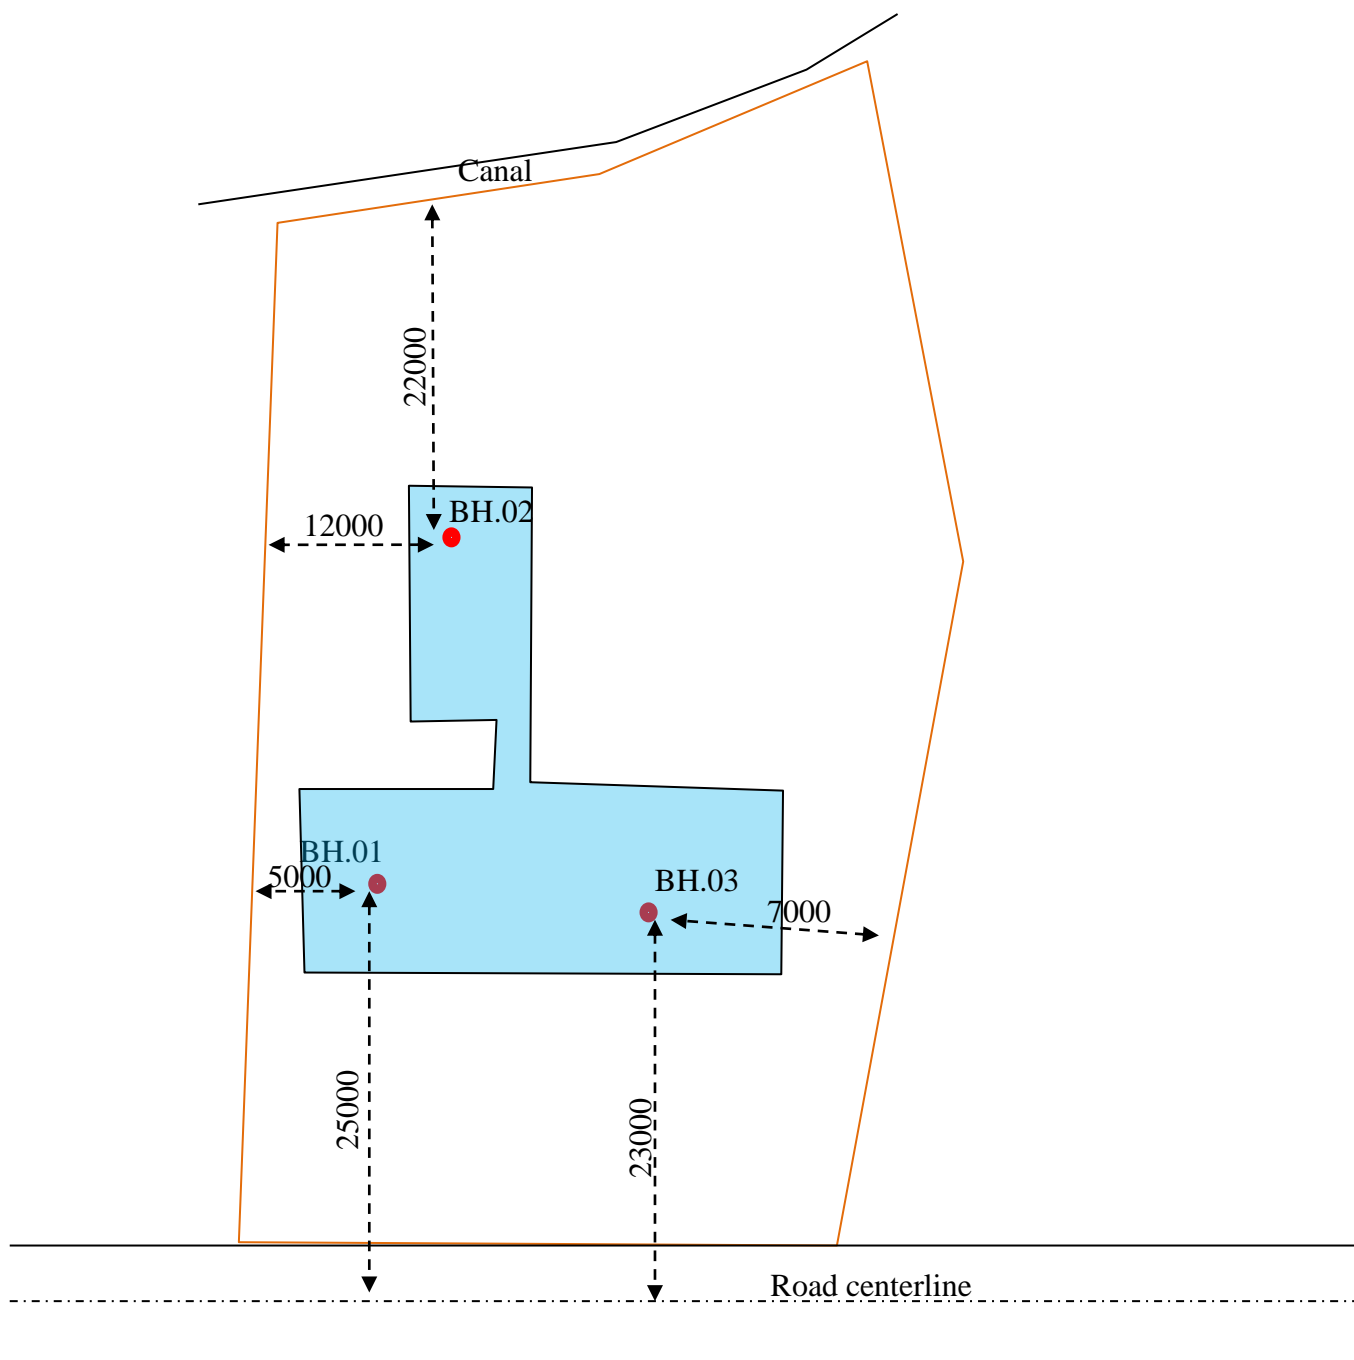
Figure 3 Borehole locations and site layout

Three boreholes, BH-01 to BH-03, had been advanced within the footprint of the proposed building adopting a **zero datum as the ground floor level** as shown in the site layout in figure 3.

Borehole/Basement	Collar Elevation (m)
BH-01	-1.10
BH-02	-2.90
BH-03	-0.60
Basement floor level FFL (3 storey front building)	-3.60
Basement floor level FFL (2 storey rear building)	-5.10

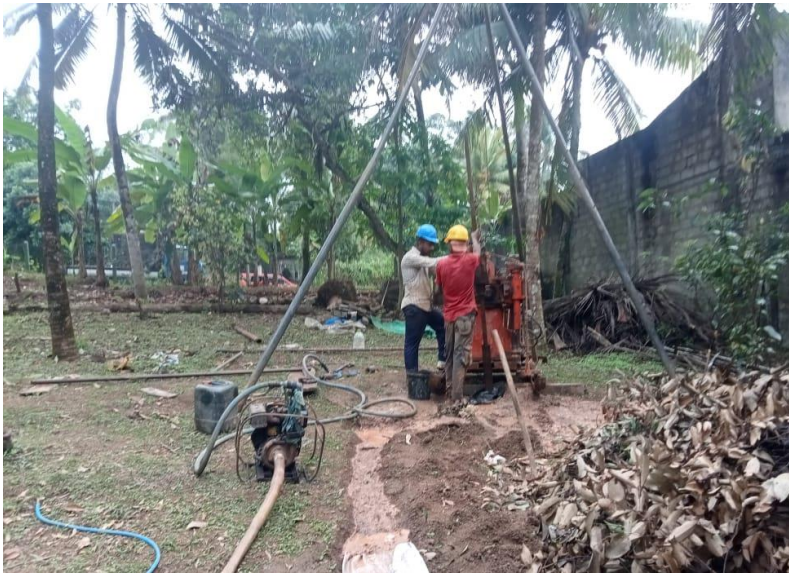
BH.01

Figure 4 Borehole investigation in progress at the site
